MOORES LAKE DAM  
BOONE COUNTY, MISSOURI  
MO. 11173

**PHASE I INSPECTION REPORT**

**NATIONAL DAM SAFETY PROGRAM.**

DECEMBER 1980

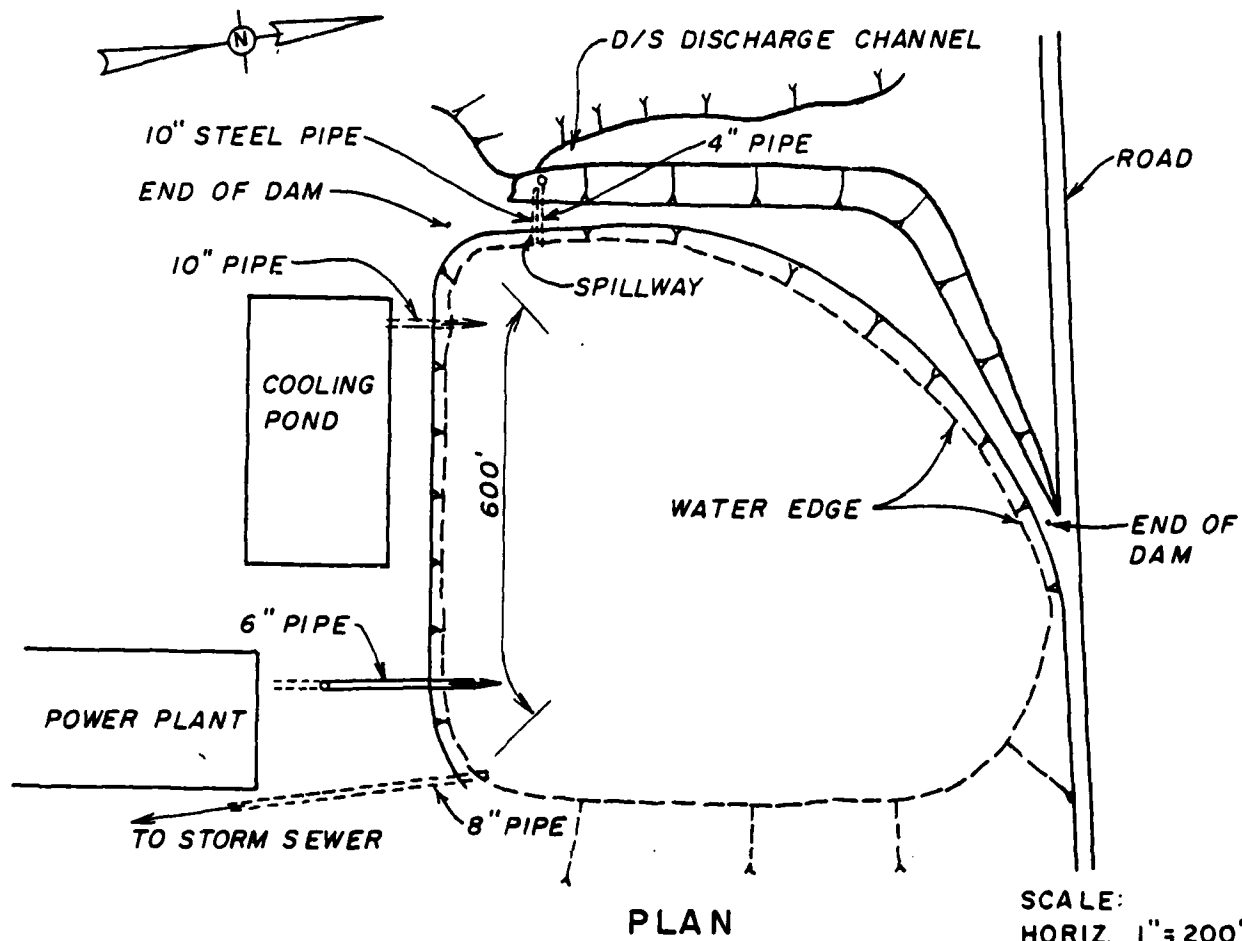
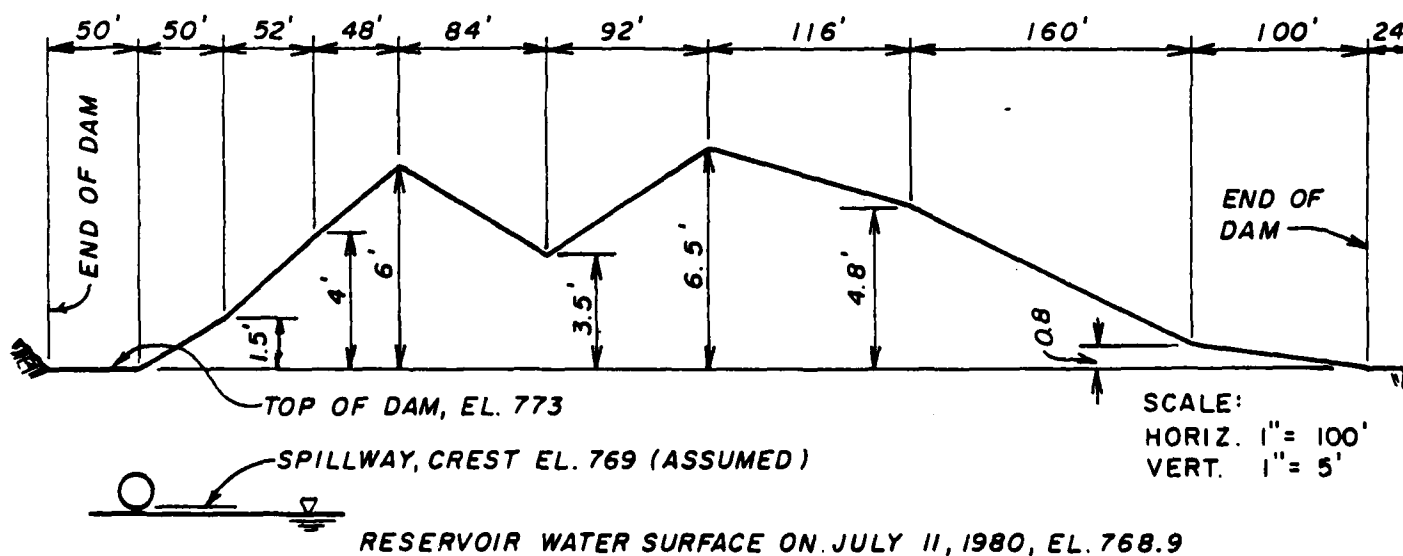
MOORES LAKE DAM (MO. 11173)  
PLAN AND ELEVATION

The 8-inch diameter pipe is located at the southeast corner of the reservoir (for the actual location see Plate 2). Flows through the pipe discharge into a creek to the south of the power plant. The top of the pipe was about 4 inches below the reservoir water surface level on the day of the inspection. This pipe, according to Mr. Gary Anderson, is going to be plugged in October of 1980. On the day of the inspection, very little water was observed flowing through the pipe, which leads the inspection team to believe that the pipe is already partially plugged. Therefore, this pipe is assumed to be abandoned and was not used to determine the capacity of the spillway system. Therefore, there are essentially only one spillway and one low level outlet utilized at this damsite.
